THE GREAT ESCAPE – NEVER AGAIN?

The Great Escape - Never Again?

On January 22, 2016, three inmates escaped from the Orange County Central Men's Jail (CMJ). The Grand Jury investigated the escape to determine how it occurred and to evaluate what steps have been taken, and still need to be taken, to ensure there are no future escapes.

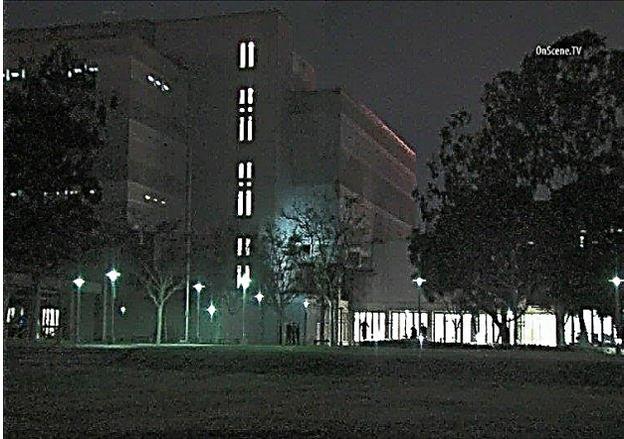
Figure 1 (Before)

Jail Perimeter Lighting: Before and After the January 2016 Escape

After the escape, it was discovered that some CMJ personnel failed to comply with various sections of the OCSJ policy and procedures manual. One such policy requires a physical check of the plumbing tunnels once per shift. The purpose of this inspection is to locate signs of tampering, identify any unsafe conditions, and observe inmates. Findings are to be documented on the applicable station log. In spite of clear policy, plumbing tunnels were not regularly checked by some deputies prior to the escape. Although maintenance workers went into the plumbing tunnels, it was only for repair and maintenance of plumbing and electrical issues and they were not responsible for inspecting the tunnels for signs of criminal activity. Since the escape, deputies now follow procedure and check plumbing tunnels for signs of illicit activity at least once per shift. In addition, plumbing tunnels have been thoroughly cleaned, existing light bulbs have been replaced with brighter bulbs, and additional lighting and motion detectors have been installed.
